## Executive Summary

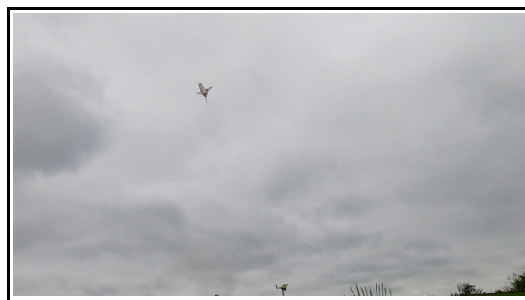
The Viper cleared the rail guide at greater than 4.0 m/sec ([video](#)). Recall, calculations showed that a minimum velocity of  $\sim 4.0$  m/sec was needed for aerodynamic control. During the launch, I had active control of the Viper and managed to maintain control until  $\sim 30$  ft. The Viper pitched down and began to roll. The Viper exhausted all of the oxidizer in this launch  $\sim 3.0$  sec before crashing into the ground. I managed to trigger the canopy just before impact.

Fortunately, the damage was minor and easily repaired. I would call this a crash I could walk (maybe limp) away from. The forward strut broke in three places and the equipment bay broke in one place. A little epoxy glue should be sufficient. As such, the next launch of the Mk I Viper should be in about a week.
