Executive Summary

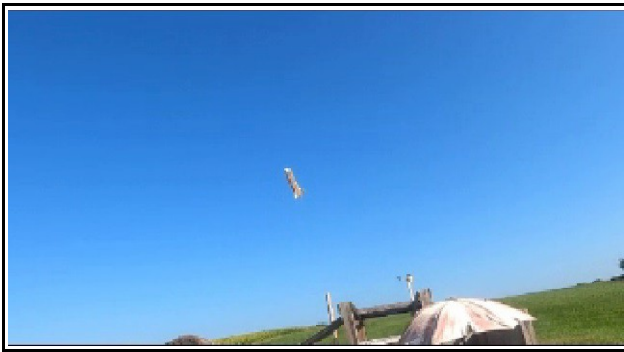
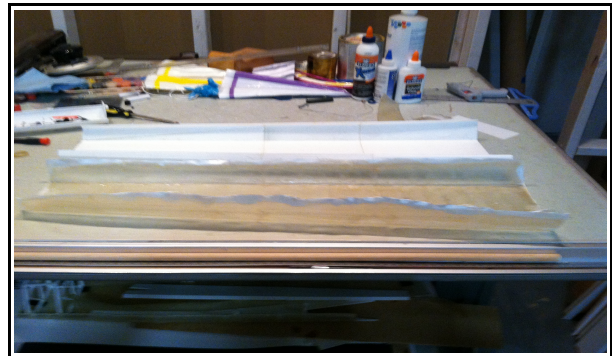
Also this month I printed a fuselage mold out of PLA (pictured below), glued the pieces together, and sanded and waxed the surface. The first fiberglass fuselage from the mold worked out better than expected. I used a metal ruler to break the bond and the fiberglass popped off with little effort. I surmise that the wax filled the pores in the PLA preventing the epoxy from bonding to the PLA making it easier to remove the fiberglass.
