Executive Summary

Technical Stuff

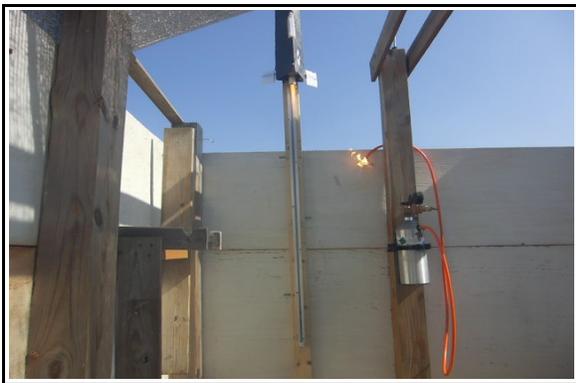
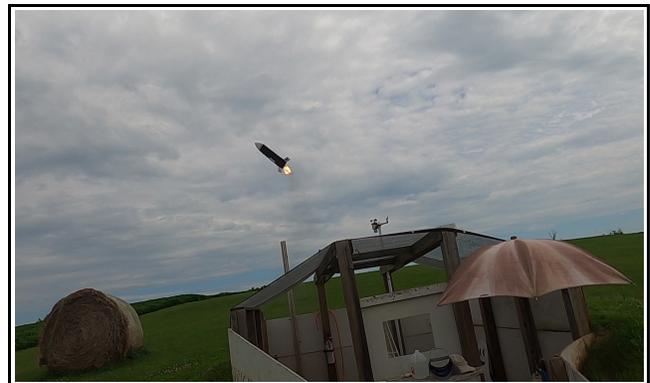
The first two flight test with the new throat diameter did not go well! In the first test, the Mk I Viper made it to the top of the rail guide, blew out the nozzle, lost thrust, broke through the stop, came off the rail guide, and crashed onto the concrete pad. In the second test, the Mk I Viper left the rail guide at ~ 1.5 m/sec, began to pitch up, blew out the nozzle, flipped over once, and crash landed next to the test stand ([Flt Test](#)).

The question is, what was causing the blowout of my graphite phenolic nozzle? All of the other parameters (with the exception of one minor parameter as noted below) were the same as before. The physical analysis revealed a significant erosion of the PLA adapter I used to install the nozzle to the 1" CPVC coupling. It appeared to erode from the bottom up. From this analysis, I surmised that I have reached a structural limit to drilling out the throat diameter of the graphite phenolic nozzle, drilling out to 6.7 mm was a little to much. Hot exhaust was leaking around the nozzle throat bypassing the o-ring seal and melting the PLA. As such, for the next test, I went back to a 6.0 mm throat diameter and increased the flow rate.
